EROSIVE WEAR OF NATURAL GAS PIPES DUE TO HIGH VELOCITY JET IMPACT: PHYSICAL EXAMINATION AND EXPERIMENTAL STUDY

Z. A. MAJID¹, R. MOHSIN² & M. Z. YUSOF³

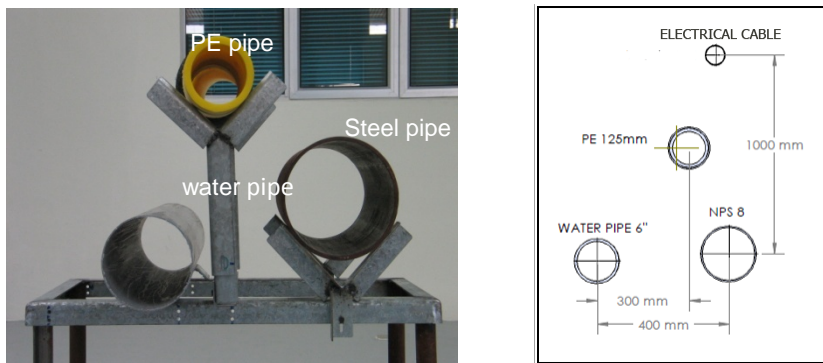
Figure 3 Reconstruction of relative pipe positions in the laboratory

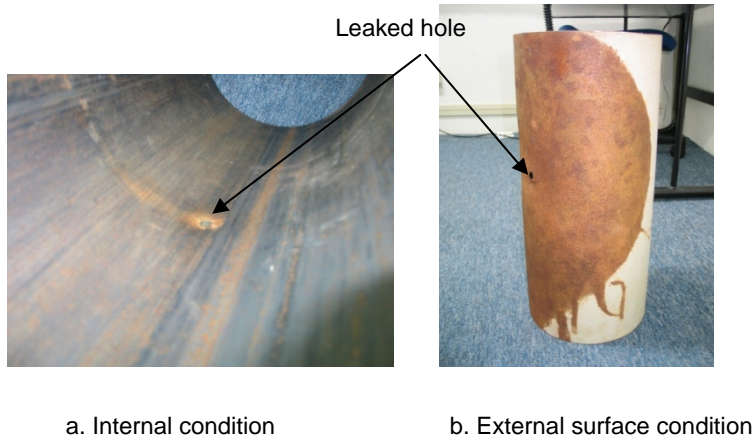
Visual inspections were carried out on both, the photographic evidence and two pipes as shown in Figures 4 and 5. The exposed part of the steel pipe (with the coatings eroded) was heavily oxidized (Figures 4b and 5a). The original condition of the exposed part (Figure 6b) was found free from coating material with clean smooth and shining condition after the incident. However the presence of an erosion marks on the pipe surface in a ripple liked shape (Figure 7a) is similar to the report by Hasan *et al.* [31]. No exhibit of scale or deposit was observed on the inside surface of the pipe thus dismay any indication of internal corrosion.

Figure 4 Failed specimen of NPS8 gas pipe

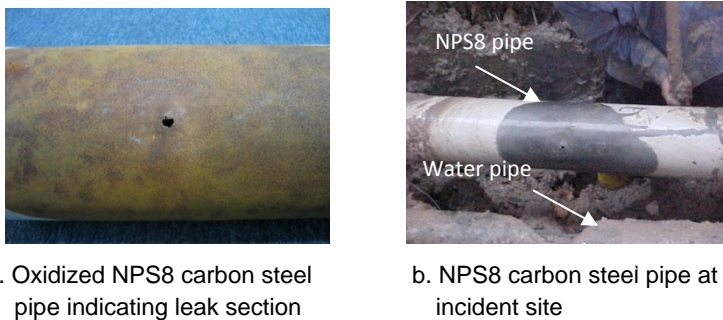
Figure 6 Surface condition of failed NPS8 carbon steel pipe

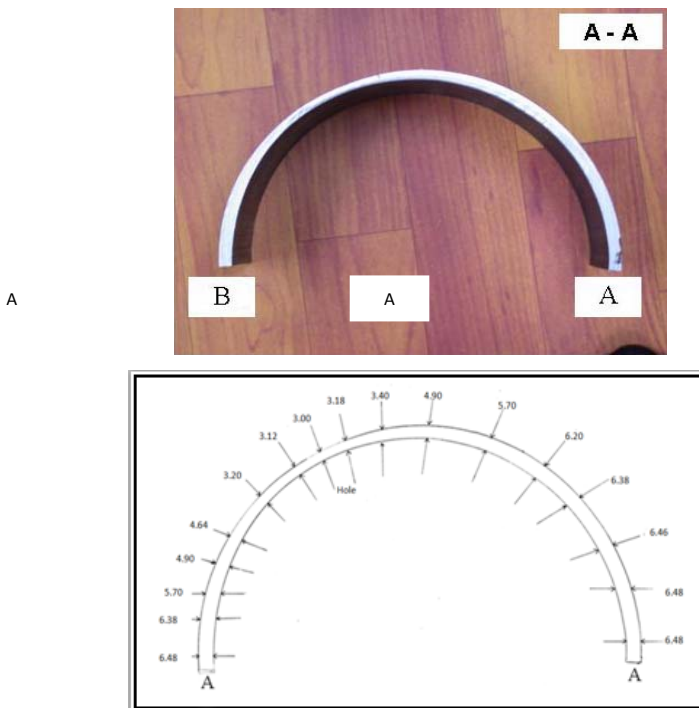
Figure 9 Thickness mapping of NPS8 gas pipe

Surface profilometry was conducted using two specimens (A and B) which were obtained from two locations around failure section at about 50 mm apart, schematically shown in Figure 8. Results obtained indicated that the thickness of the metal decreased substantially against the identified leak point as illustrated in Figure 9a for specimen A and Figure 9b for specimen B. Continuous metal losses surrounding the impact area of water jetting had initiating a serious crack growth (pinhole) caused by drastic erosion process. Figure 10 indicates jetting direction and its dispersion against NPS8 pipe wall that had caused erosive wear on pipe wall.

a. Thickness mapping for section A - A (50 mm away from hole)

b. Thickness mapping for section B - B (half way through the hole)
