An Experience of Ageing on XLPE Insulation

A case study of ageing on XLPE conductor insulation of 20kV primary distribution feeder is presented in this paper. The insulation degradation mainly occurred around conductor tie where the conductor is attached to the post insulator. A section of distribution feeder with defects on the conductor insulation has been examined for this study. Potential losses due to presence of discharges have been investigated by measuring the difference current at locations of the affected conductor. Temperature measurements of the insulation surface have also been carried out. Provisional maintenance procedures were introduced to eliminate the discharges. Measurements of current and surface temperature were repeated nine months after completion of the maintenance work. Results indicated that the discharges have been completely disappeared.

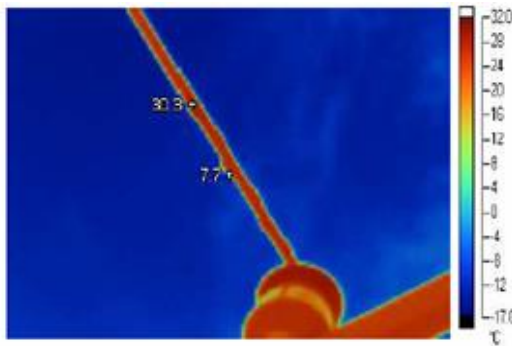
Figure 4 shows a typical image from the utilised thermo vision camera. The camera may identify a temperature variation within the aimed area. The average temperature of the conductor sheath near the discharge locations were recorded for this study.

Figure 4 Typical image from the thermo vision camera

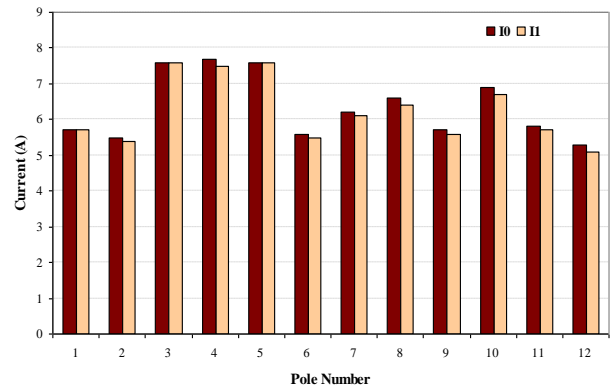
Current measurements were carried out before commencing and after completion of planned maintenance works. The measurements and maintenances were carried out during dry season. The current measurement results of the red, yellow and blue phases for the twelve poles before maintenance are presented in Figure 5 to 7. Bars with darker colour indicate incoming current (I_0), while those with lighter colour indicate outgoing current (I_1). It is clear that the difference current exists which is indicating the potential power loss at most of damaged insulation sections.

The measured quantity of flowing current on the conductor depends on the load of the remaining part of the feeder at the time of measurement. The magnitude of difference current varies from point to point of measurements, with an average value of 0.108A for the red phase and of 0.117A for the yellow and the blue phases. This evidence is depicted in Figure 8, where less discharge events occurred on the red phase compared to that on the yellow and blue phases.

Figure 5 Measured current of red phase

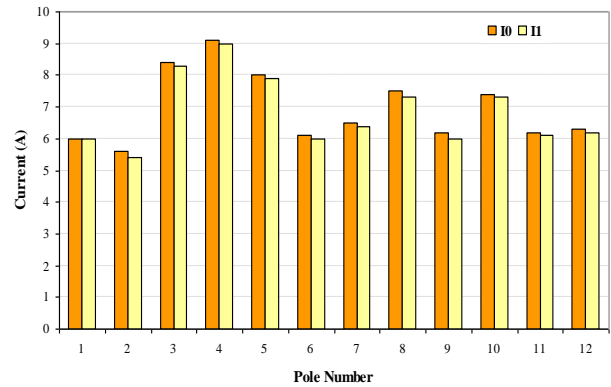
Figure 6 Measured current of yellow phase

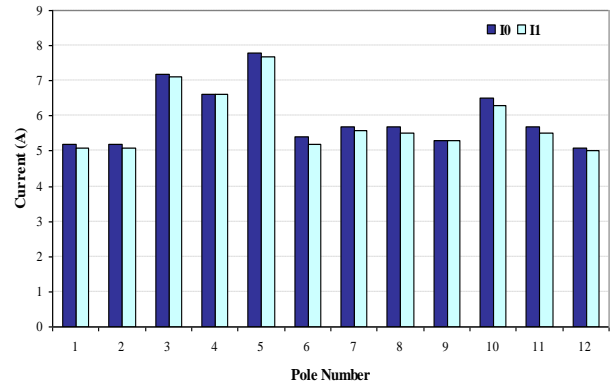
Figure 7 Measured current of blue phase

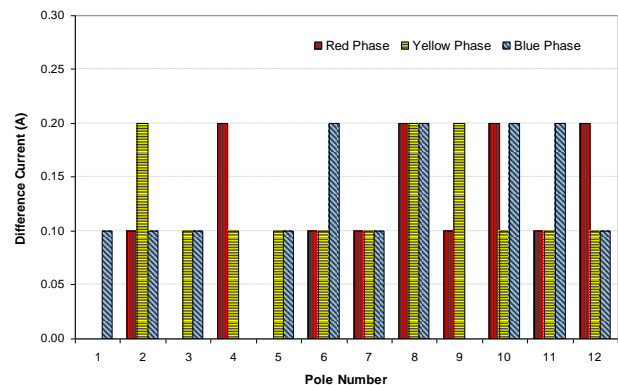
Figure 8 Difference current measured at the twelve poles

Potential power loss at all phases was identified at seven out of twelve explored poles, while potential power loss at only one phase was discovered for one pole. This fact indicates that the insulation damage occurred around conductor tie at all the investigated twelve poles. The results also designate that at 91% of the total number of poles, the insulation ageing involves two or more phases.

Following the identification of defects on the XLPE insulation, immediate life maintenance works were carried out to prevent further defects on the conductor. Measurements of the flowing current were repeated after completion of the maintenance. There was no indication of difference current during the second measurement.

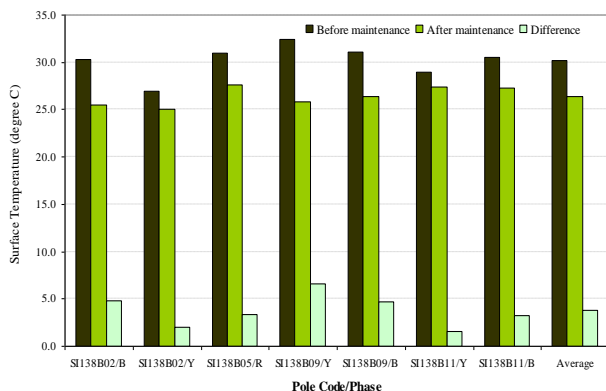
Figure 9 shows the surface temperature of the XLPE sheath before and after maintenance works at a number of investigated poles and particular phases. Note that not all defect points were measured for surface temperature. Measurements were carried out randomly on poles with an identification number of 2, 5, 9 and 11, as shown in the figure. The average temperature of the XLPE sheath surface near defect locations (before maintenance) is slightly above 30°C. In contrast, after completion of the maintenance works, the approximate average XLPE sheath surface temperature became 26.5°C. There was a reduction of about 3.5°C in surface temperature of the XLPE sheath after maintenance process was completed.

Figure 9 Surface temperature of the XLPE sheath
