Evaluation on Crack Pattern of Concrete Masonry Wall Column

Keywords: Concrete Masonry Unit (CMU); wall-column; crack behaviour; axial forces

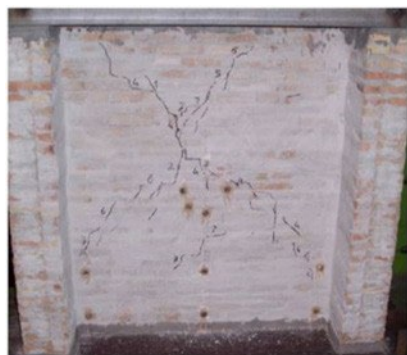
FIGURE 1. Shear cracking damage of HURM wall

subjected to in-plane cyclic loading. The walls were placed in in-plane cyclic loading condition shown in Figure 1. The shear damage with the diagonal cracking of the walls were strengthened by using CFRP strips bonded. It is connected by arranged both vertically and horizontally and laid out corner to corner. In order to enhance the adhesion of the CFRP strips to the wall surface, a system of steel nails and short carbon fibers were arranged and inserted into the holes and it was test subjected to cyclic loading until the walls fail. (Capozucca 2011).

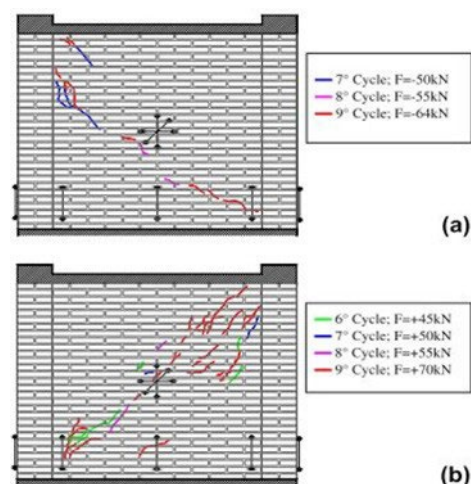
FIGURE 2. Experimental cracks on the unreinforced side of HRM wall

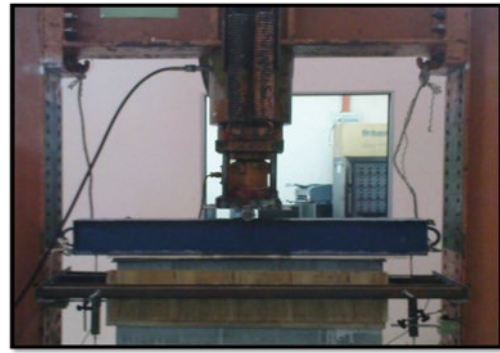
FIGURE 5. Setting out of bottom bracing

The top brace is protected by two 100 mm x 1500 mm iron C-purlin ends. Plywood is shaped to have a smooth and wide contact area between C-purlin and the surface of the wall. Roller roles are 50 mm diameter steel rod roles. Eccentricity is controlled by changing the location of the wall of the CMU. The 12 mm diameter steel rod is used to carry both sides of the C-purlin to stabilize each other. Two sides of 100 mm x 1500 mm iron C-purlin are also protected by the bottom bracing. Stiffeners are mounted only on one side to prevent bending of C-purlin. Walls are pinned supported, and the load is distributed by spreader beam. The height of spreader beam is 500mm. Top bracing is supported by two side of iron C-purlin of 100mm x 1500mm. Plywood is placed to give soft and large area of contact between C-purlin and wall surface. Roller is roles by steel rod of 50mm diameter. Eccentricity is control by adjusting the positioning of CMU wall. Steel rod of 12mm diameter is used to brace both side of C-purlin to support each other. Bottom bracing is also supported by two side of iron C-purlin of 100mm x 1500mm. Stiffeners is placed to avoid bending of C-purlin in one side only. Channel is used at the bottom of the wall as a bracing as shown in Figure 6.

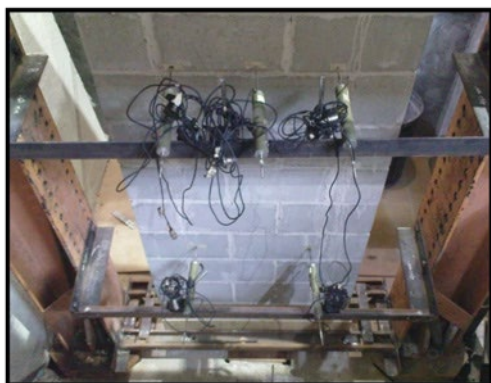
FIGURE 6. Setting Out of LVDT

The testing of infilled CMU wall-column is conducted using 200 tones testing frame in pit. Specimen is subjected under axial load until reach ultimate load. Axial shortening is measured using Linear Variable Differential Transformer (LVDT) place under spreader beam. Figure 7 and Figure 8 shows details of CMU wall-column setting out. Lateral displacement is measured by placing LVDT at various heights. All the data is recorded using data logger. At every incremental of load, the reading of LVDT and strain gauge will be recorded until the failure of the wall. The cracking pattern and mode of failure was observed as a load increase. Before the sample can be tested, all the wiring of reading devices such as LVDT and strain gauges has been connected to the data logger. The raw data from this experiment was analysed and the result was graphically display.

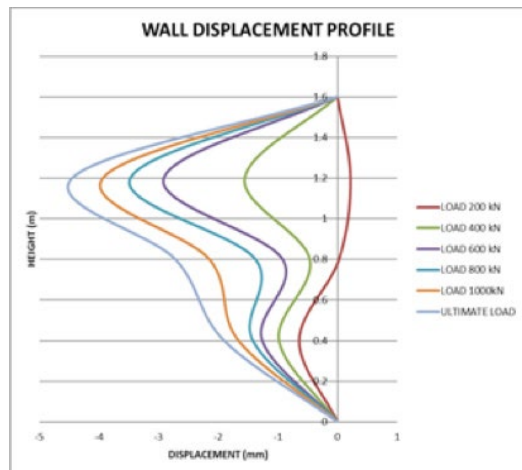
FIGURE 9. Wall Displacement Profile of CMU Wall-column

Figure 9 and Figure 10 shows the graph of wall displacement profile for both wall-column. Based on the test results that have been carried out, the 190x1000x1600 Y12 sample appears to bend more at 1200 mm from the wall soffit. This behavior proves the fact that from the top of the wall, the bending moment is stronger at 1/4 height from the top of the wall. Furthermore, LVDT are not placed at the top and bottom walls, so to achieve a lateral displacement profile, it is safe to consider as zero displacement.

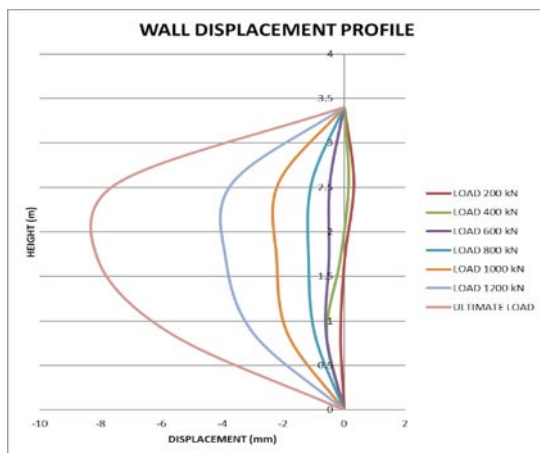
FIGURE 10. Wall Displacement Profile of sample 190x1000x3400, Y12

Sample 190x1000x3400 Y12 is known as slender wall. The findings of the analysis showed that the bending moment approaches the maximum limit at the center of the wall. At the ultimate load, the lateral displacement becomes greater than the loading of 1200kN. Thus, it can be illustrated by the fact that the wall starts to bend more faster when the ultimate load is nearly to archived. After initiate at certain loading, the cracking of the wall was observed start at the early state of the experiment. Crack also lies at the corner of the wall-column and after reach a maximum loading the diagonal crack was occur at the wall. All the cracks was lie along the mortar joint. The difference crack at the top and bottom of the CMU wall-column. From the observation of

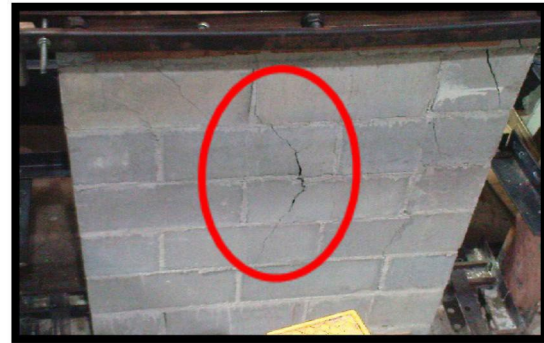
FIGURE 11. Out-of-Plan Crack of Masonry Wall-Column

the experiments, each sample representative failure modes are presented in Figure 11 and Figure 12. The difference between the brick joint interfaces described both samples. In the top and bottom portion of the samples, some slight cracking was found, and no pure vertical cracking was observed.

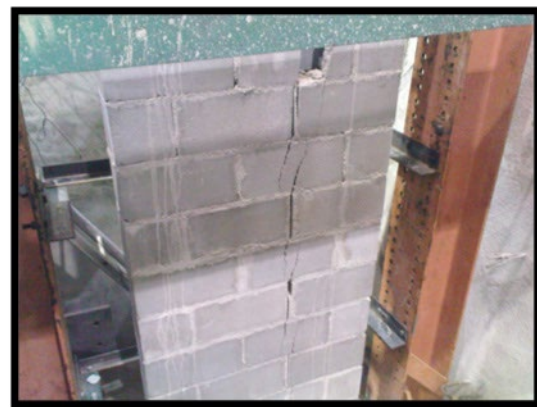
FIGURE 12. Crack due to tensile failure

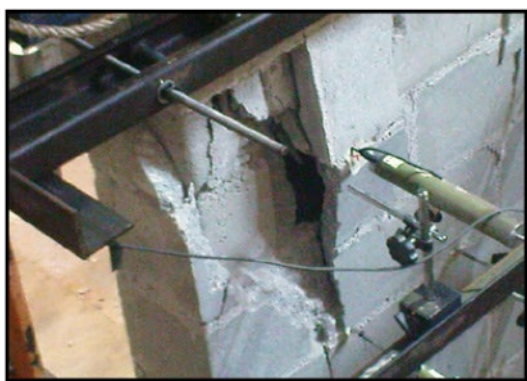
FIGURE 13. Local crushing on masonry

The applied lateral load on the sample was induced the alternate tension and compression stress. The cracks have developed whenever the wall surface subjected to tension stress. It was discovered that a lot of cracks have propagated in the range of moderate to high stresses in the wall surface. Sample 1, CMU Wall-column with height of 3440mm, the optimum load is 1370.03 kN and for sample 2. CMU Wall-column with height of 1600mm, the optimum load is 1121.4kN. The wall failed due to local crack on masonry and cause by weakness of mortar joint. The gravity loads apply to the wall act as a gravity load (axial force) to strengthen the mortar joint of the wall. The crack was appearing at the second layer for both wall because at that layer, there is no reinforcement and concrete fill into the masonry unit (uninfill block). Furthermore, there is some error during the construction stage, where there is no starter bar that tie column and foundation. This had caused the wall to fail earlier due to local crack on masonry.

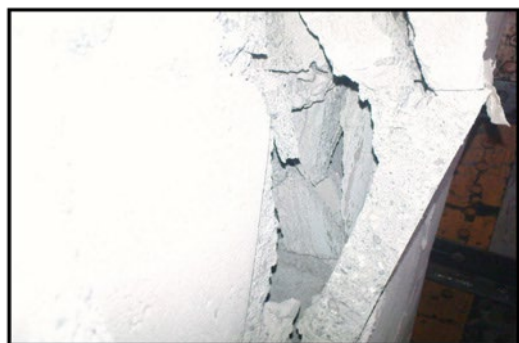
FIGURE 14. The inside of wall view

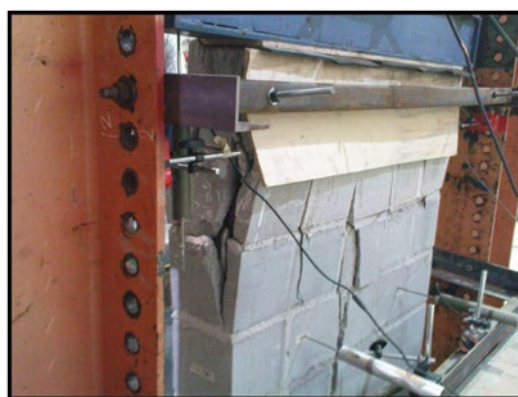
FIGURE 16. Local crushing on masonry

of the starter bar to the column reinforcement. These prevent the connection from holding the wall to move on during the experiment. The opening between mortars along the wall was measured. It is seen from the calculation that the maximum displacement took place at 190 mm from the bottom of the wall. Same as wall 1, the first crack of wall 2 also occur at the first layer of the masonry wall-column. At this stage, several horizontal cracks occurred along the mortar joint and surface of the wall-column. As a load increase more cracks appeared at the foundation of the wall-column and the crushing occurs on the surface of the wall as shown in Figure 15 and Figure 16.
