PRELIMINARY STUDY ON ADDITIVELY MANUFACTURED PLASTIC LINER OF AN ACETABULAR CUP COMPONENT

Sofia, J.^a, Ethiraj, N.^{a*}, Nikolova, M. P.^b

^aDepartment of Mechanical Engineering, Dr.M.G.R Educational and Research Institute, Maduravoyal, Chennai – 600 095, Tamilnadu, India

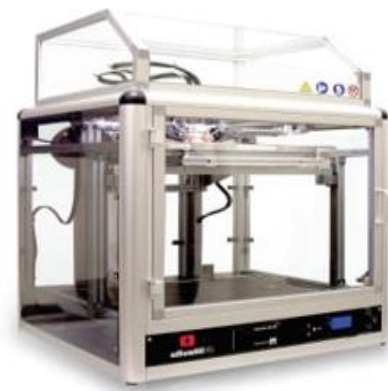
Figure 1 General View of the FDM Machine Used

The acetabular liner component was fabricated using a polylactic acid filament with a diameter of 1.75 mm. The additive manufacturing method used for fabricating the desired component was fused deposition modeling (FDM) in Olivetti S2 – 3D Industrial Grade 3D Printer with 0.4 mm nozzle diameter as shown in Figure 1. The dimensions of the liner are presented in Figure 2. The selection of the process parameters for the preliminary study is based on the recommendation made by the PLA material manufacturer and the machine manufacturer. The following process parameters were used for printing; printing speed - 45 mm/s with an infill of 30%; infill pattern – rectilinear; layer height - 0.3 mm; bed temperature - 60°C; print temperature - 205°C. The infill density percentage has a significant effect on the mechanical properties of the component. Also, the lower percentage infill is used for rapid prototype models and higher percentage is used for end-user products. Based on the component shape, time and cost of printing material consumed and thereafter obtaining the considerable mechanical properties, the infill percentage is fixed at 30%. The physical and mechanical properties of the polymer used and comparison with UHMWPE are described in Table 1.

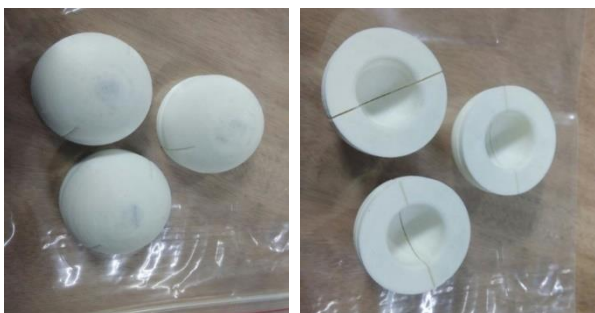
Figure 3(a) External Surface View and (b) Internal Surface View of 3-D Printed Liners

The acetabular cup liners fabricated by 3D printing process using PLA material are shown in Figure 3. The results of the representative dimensions measured by CMM are presented in Table 2.

It is observed from the results in Table 2, that the maximum percentage of deviation between the measured and actual dimensions is 1.1. Also, it is seen

that the outside dimensions are oversized and the inside dimensions are undersized. The minimum and maximum variations in dimensions observed are 0.01 and 0.5 mm respectively. This may be attributed to the oozing of material from the outside surface and shrinkage caused by heating and subsequent cooling of the material on the inside surface. The oozing of the material may be due to the low viscosity caused by the higher temperature of the material printing rather than the desired one.

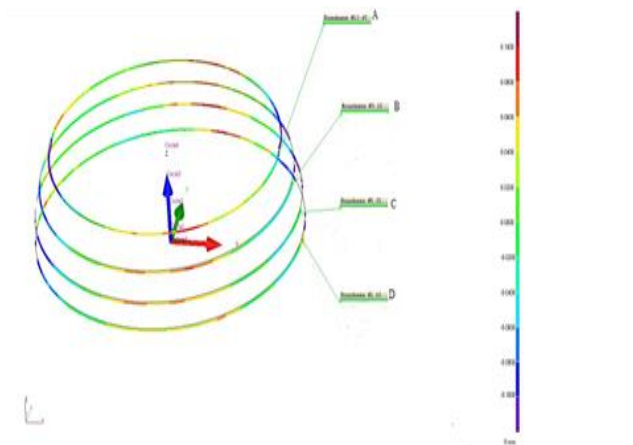
(a) CAD representation of Surface roundness measurement at four surface
