TEMPERATURE RISE OF COLD-FORMED STEEL BUILT-UP BACK-TO-BACK COLUMN UNDER STANDARD FIRE

Fadhluhartini Muftah^{a*}, Mohd Syahrul Hisyam Mohd Sani^a, Shahrin Mohammad^b, Shek Poi Ngjan^b, Mahmood Md Tahir^b

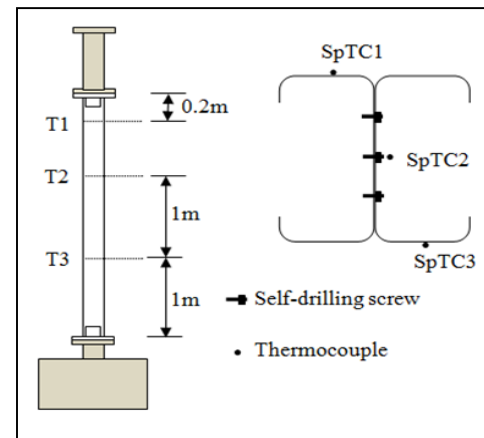
Figure 1 Location of thermocouple on the column

Type K. Table 1 provides the notation for the thermocouple used in this study. Based on the recommendations of BS EN 13381-4:2013 (E) [14], the thermocouple was positioned along the column height as shown in Figure 1. It can be observed that thermocouple was attached to the column's section at the flange and the web. Besides that, a static test of the built-up BTB column was conducted at ambient temperature to determine the capacity of the column. According to this static test, a load ratio known as the degree of utilization is considered to evaluate the temperature rise in the column and finally determine the fire resistance of the column. During the fire test, the column was loaded at a constant load level as in real structure application. The load was left for constant until reach stable condition for 10.0 minutes before the fire induced. Then, fire was blown to the column inside the furnace until the column failed. The temperature rise in the column was monitored. The column was loaded using a hydraulic jack loading system with maximum loading of 1000.0 kN. The load applied was at 0.25 kN/s for both ambient and fire condition.

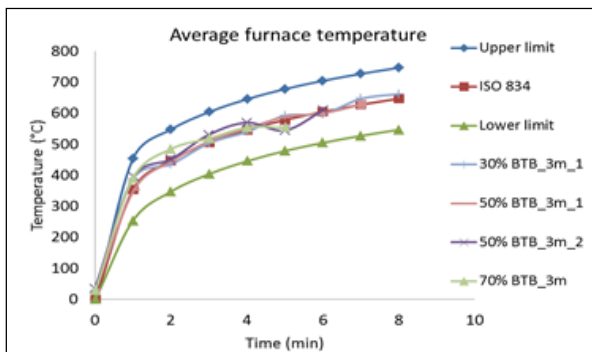
Figure 2 Average furnace temperature

Four thermocouples were placed inside the furnace to determine the temperature of the fire. The average value was demonstrated in Figure 2. All furnace temperatures that burned the four built-up BTB columns showed a consistent temperature rise according to the standard ISO 834 [16] fire curve. The temperatures and pressure in the furnace were within the limit given in BS EN 1363-1:2012 (E) [15].

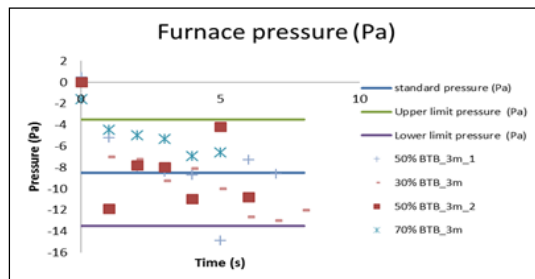
Figure 3 Furnace pressure inside furnace

The standard fire curve in function of the temperature and time was $\theta_g = 30 + 345 \log_{10} (8t + 1)$ where θ_g is the gas temperature in unit $^{\circ}\text{C}$ in the fire compartment and t is the time in minutes. In order to determine the acceptance of the fire induced to the columns, BS EN 1363-1:2012 (E) [15] had the limit of 15.0 % percentage deviation (de) in the upper limit and lower limit of standard the temperature/time curve. The furnace used to have six fire blowers and its pressure was also monitored according to the recommended BS EN 1363-1:2012 (E) [15], pressure

inside the furnace, which is approximately 8.50 Pa per metre the height of the furnace and must be within ± 5.0 Pa after 5.0 minutes of fire.

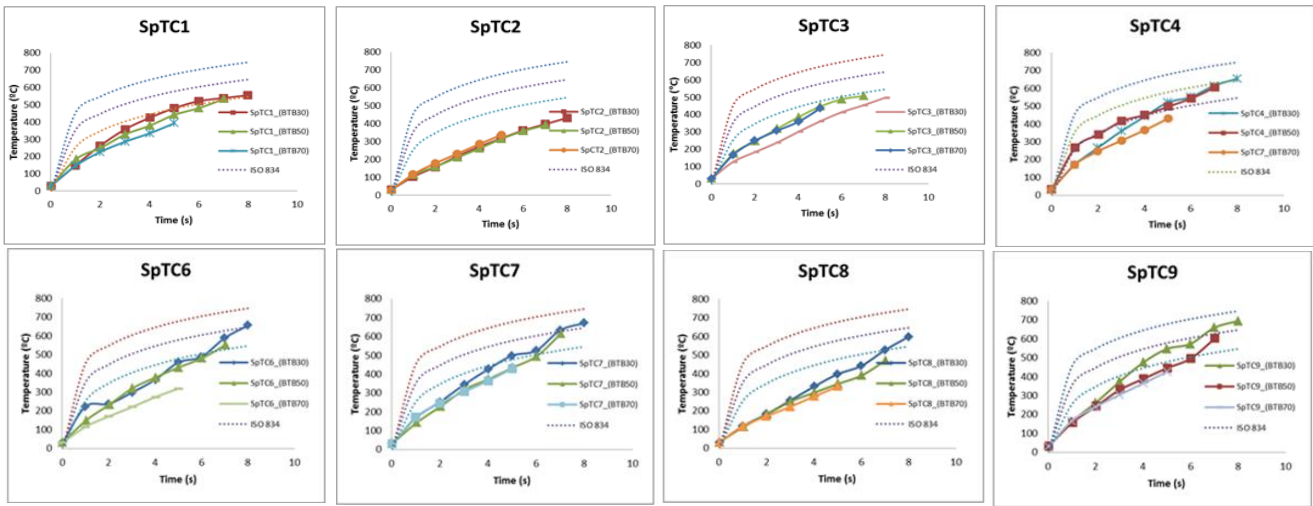
Figure 4 Temperature rise in built-up back to back column

Figure 4 shows the recorded thermocouple at each station on the BTB column for different degrees of utilization. Only eight out of nine thermocouples give reliable results. This is the cause of an error such as positive, negative conductor touch to each other due to fracture of ceramic that cover both conductors due to impact during column failure in previous test. Thermocouples located at 200.0 mm from top support and loading is known as SpTC1-SpTC3. The rise of temperature at this location is below the standard fire ISO 834 [16] for all degrees of utilization until the column fails. The temperature recorded for SpTC2 that located at the column web is lower than the SpTC1 and SpTC3 that located on the flange respectively. The same temperature behaviour of built-up I-section was found in the study conducted by [13] which the temperature at the web registered lower temperatures than the ones of the flanges. This might explain that the greater thickness of the web and the thermal conductance between the two CFS profiles [13]. This behaviour also found for all thermocouple at other level in the column. SpTC4 and SpTC6 is thermocouple placed at 1 meter from top of column flanges respectively. It was found that rise of temperature is faster compared to the top side. The rates of temperature rise are almost similar for SpTC4 and SpTC6. SpTC4 and SpTC6 for 70.0 % degree of utilisation have risen up to ISO 843 [16] fire curve at failure while for 30.0 % degree of utilisation, the column was failed at lower temperature. SpTC7-SpTC9 recorded the temperature for lowest side at 2.0 m from loading. It was observed that the SpTC7 and SpTC9 also recorded higher value in that level. In addition, the values in this level are slightly higher to the thermocouple at the middle level. The rate of temperature rise was also similar for different degrees of utilisation. It can be concluded that the rate of temperature rise of the BTB CFS column is constant for CFS and in-dependent to the degree of utilisation.

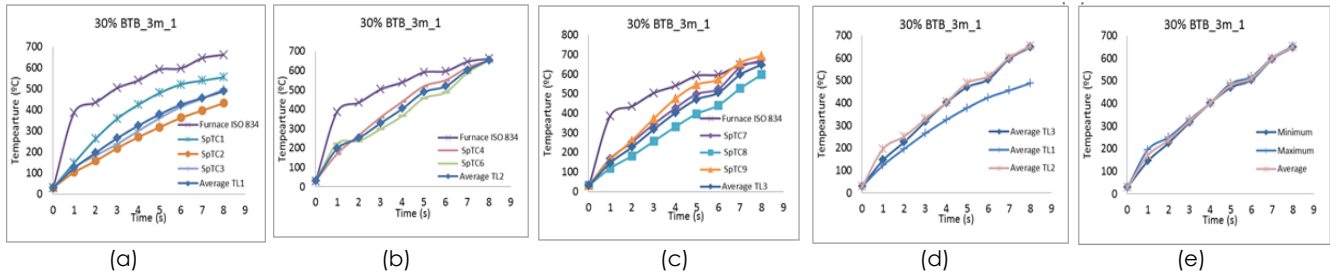
Figure 5 Evaluation of mean temperature along the column for 30.0 % degree of utilisation

Figures 5-7 show the rise of temperature recorded on a BTB column fewer than 30.0 %, 50.0 % and 70.0 % service load which were exposed to standard fire. All of the columns had the same behaviour of temperature rise where the upper side of thermocouple registered lower temperature until the columns' failure. This might be caused by the thermocouple was located nearer to the ceramic fibre which supported the column end. The heat was shielded by a ceramic fibre that restricted the conductance of heat to this position. Thus, it was expected that the failure of 30.0 % degree of utilisation column failed the temperature increase in the column. Meanwhile, Figures 7(a)-(c) show the column temperatures in the BTB column. In the meantime, the middle and bottom level recorded temperatures that approached the standard ISO fire. The columns failed as all thermocouple at the middle level reached the temperature of ISO fire. The column with a 50.0 % degree of utilisation showed that the bottom side of the column had reached the temperature of ISO fire. Meanwhile, the column with 70.0 % degrees of utilisation were recorded none of the temperature had reached the ISO temperature at failure. This temperature behaviour was due to the high load applied, which caused the column to have large deformations and had reduced its stiffness faster when heat induced. According to the temperature recorded, the column with the lower degree of utilisation failed due the temperature of the column had reached the standard fire. For the moment, the columns with a higher degree of

The evaluation of mean temperature along the column was calculated by using the weighted area methods in which the temperature recorded were multiplied to the area of the column surface [13]. It was observed that the web temperature was lower than the flange temperature and average value lead to the lowest average value. Figures 5-7 (d) show the average value at each thermocouple level. It was found that all degrees of utilization column had recorded a non-uniform temperature at its cross-section for all different levels. The column with a 30.0 % degree of utilisation had a higher temperature at TL3 and TL2, while columns with 50.0 % and 70.0 % degree of utilisation had a higher temperature for TL2. This might be caused by T1's location was nearer to the column supported with ceramic fibre which caused it to register a lower temperature. Hence, it was ideal to account T2 and T3 to get the mean temperature in the column. Figure 5-7 (e) shows the minimum, maximum, and average values of temperature. While the columns with 30.0 % and 70.0 % degree of utilisation obtained close results with the temperature, hence the average value is used. On the other hand, the columns with a 50.0 % degree of utilisation, had a big difference in the value of temperature, thus, the minimum value is used. Table 2 tabulates the mean temperature of the column.

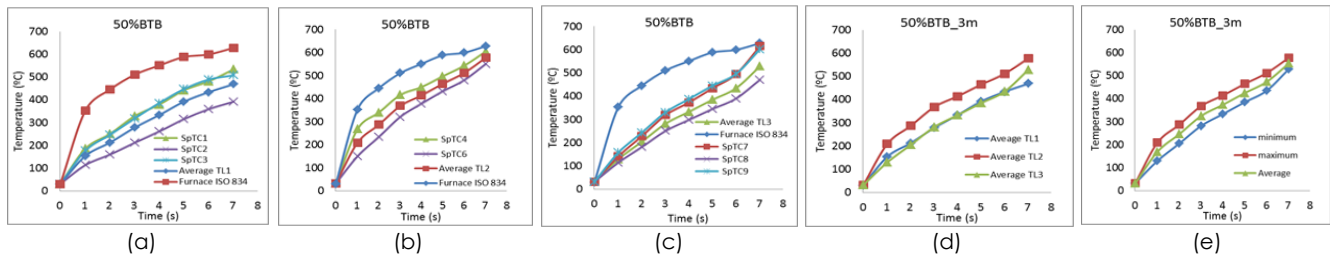
Figure 6 Evaluation of mean temperature along the column for 50.0 % degree of utilisation

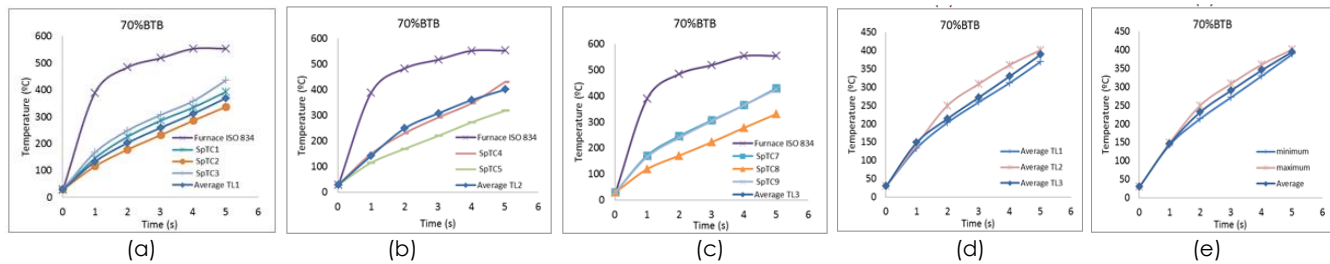
Figure 7 Evaluation of mean temperature along the column for 70.0 % degree of utilisation

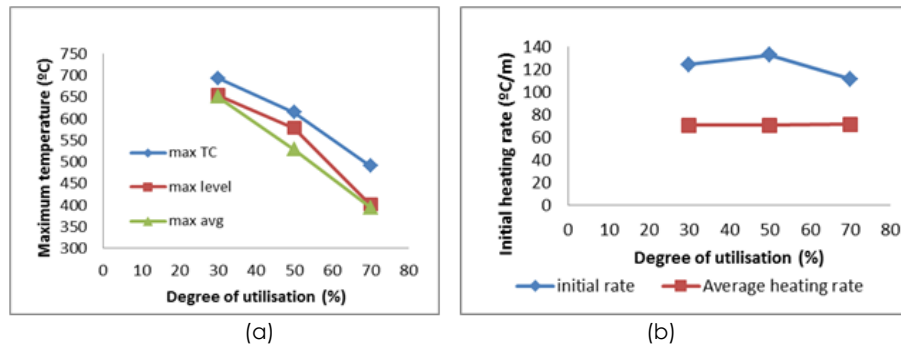
Figure 8 (a) Evaluation of critical temperature (b) Heating rate of the column

The philosophy of fire design is particularly concerned with preventing structural collapse before the specified fire resistance period. The design of the critical temperature or collapse temperature of structural element is considered uniform temperature. The evaluation of critical temperature is done by evaluating the results of the maximum recorded thermocouple from the experiment, the maximum values from the average of each level, and the maximum value from the mean

temperature. Figure 8 (a) plots all the values for all degrees of utilisation. Furthermore, for fire safety reasons, the ideal critical limiting temperature was taken as the smallest value which was based on the maximum mean average. As expected, the resistant time was decreased as the load applied to the column was increased. Then, both the initial and average heating rates of the column were calculated. The Initial heating rate was calculated using the temperature recorded in the first minute, while the average heating rate was based on the temperature and time of the column failure. Figure 8 (b) showed the effects of load towards the heating rate of the column. The heating rate of the channel column does not depend on the load apply and it was also reported by [13]. The heating rate was almost constant for the BTB column at all load levels at 70.0 °C/min. The initial heating rate is generally higher at 123.0 °C/min for column because the first 1 minute, the rate of ISO 834 [16] is higher at 329.0 °C/m. The critical temperature was 651.0 °C, 529.0 °C and 395.0 °C and critical time was 8, 7 and 5 minutes for 30.0 %, 50.0 % and 70.0 % degree of utilisation respectively. As the degree of utilisation is increased, the critical temperature and time is decreased.
