An Experience of Ageing on XLPE Insulation

A case study of ageing on XLPE conductor insulation of 20kV primary distribution feeder is presented in this paper. The insulation degradation mainly occurred around conductor tie where the conductor is attached to the post insulator. A section of distribution feeder with defects on the conductor insulation has been examined for this study. Potential losses due to presence of discharges have been investigated by measuring the difference current at locations of the affected conductor. Temperature measurements of the insulation surface have also been carried out. Provisional maintenance procedures were introduced to eliminate the discharges. Measurements of current and surface temperature were repeated nine months after completion of the maintenance work. Results indicated that the discharges have been completely disappeared.

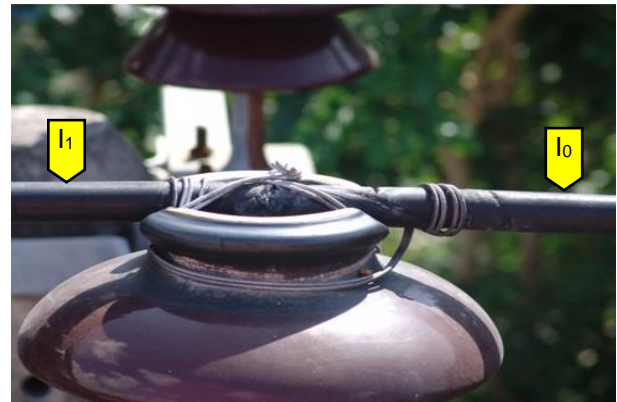
Figure 3 Location of current measurements

Figure 3 depicts the locations of current measurement near a conductor tie of a section with damaged XLPE sheath. The markers on the picture are for indication only. The exact locations of current measurements were further left and right to accommodate all damaged insulation segments. The clamp meter used to measure I₁ has similar characteristics to that used to measure I₀.

Following the identification of the insulation damage, a life maintenance procedure was carried out. This work was aimed to prevent further defect on the conductor strand due to high energy discharges. The work includes tie changed and removal of the affected conductor sheath. Consequently there are some parts of the lines became completely bared at the tie points.
