Enhancing Slope Stability with Different Slope Stabilization Measures: A Case Study using SLOPE/W Software

Juliana Idrus*, Norhanizah Hamzah, Rozaini Ramli, Masyitah Md Nujid & Siti Fatimah Sadikon

Civil Engineering Studies, College of Engineering, Universiti Teknologi MARA, Cawangan Pulau Pinang, Permatang Pauh Campus, 13500 Pulau Pinang, MALAYSIA

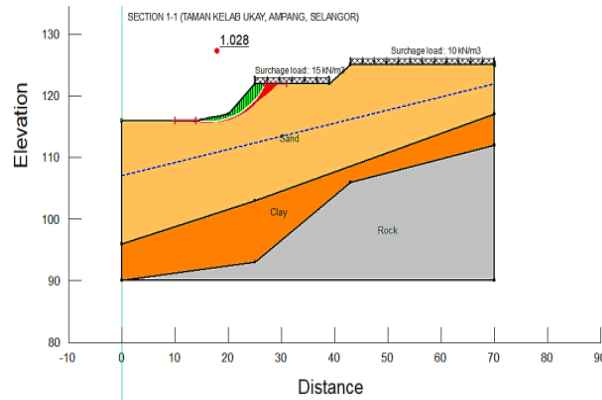
FIGURE 2. The existing slope with a FOS of 1.028 (output from SLOPE/W software)

The slope stability analysis result shows that the existing slope's FOS is only 1.028, as shown in Figure 2. The output indicates that the existing slope does not meet the minimum FOS of 1.30. According

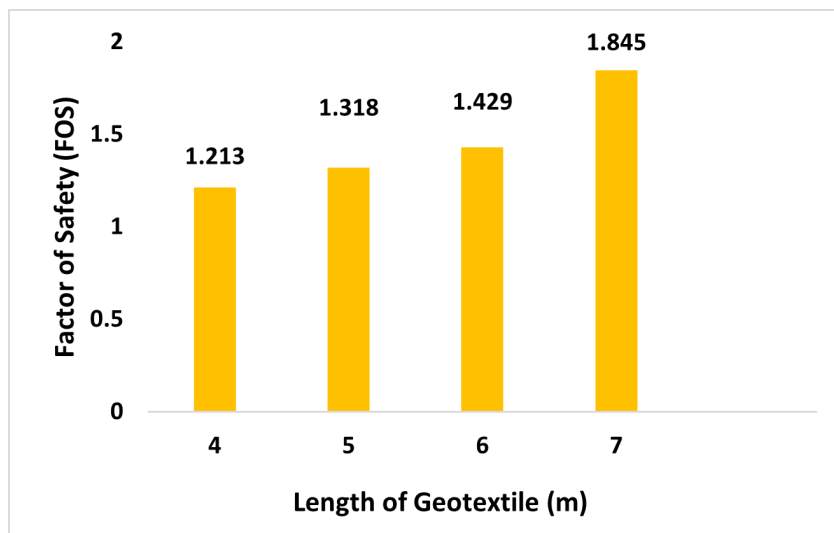
FIGURE 3. The result of FOS for various geotextiles length

Geosynthetic is widely used in geotechnical and geoenvironmental structures to perform reinforcement, drainage, filtering, separation, barriers, and protection (Palmeira & Totto 2015). Geotextile is one of the corrective measures acting as tensile reinforcement to stabilize the slope. In this study, different geotextile characteristics are investigated, and the results of slope stability with three (3) layers at various lengths from 4 meters to 7 meters are shown in Figure 3.

Figure 3 shows the apparent trend of increasing FOS where the value is improved from 1.213 to 1.845. The implementation of 4 meters length indicates the lowest FOS of 1.213. In contrast, the 7 meters geotextiles offer the most significant FOS value of the slope, which is 1.845. From the findings, it is proved that the 7 meters length fulfils the minimum requirement of JKR. The parameters for designing geotextiles as a remedial measure for this case study are listed in Table 2, and Figure 4 shows the output of the slope stability analysis from SLOPE/W software.

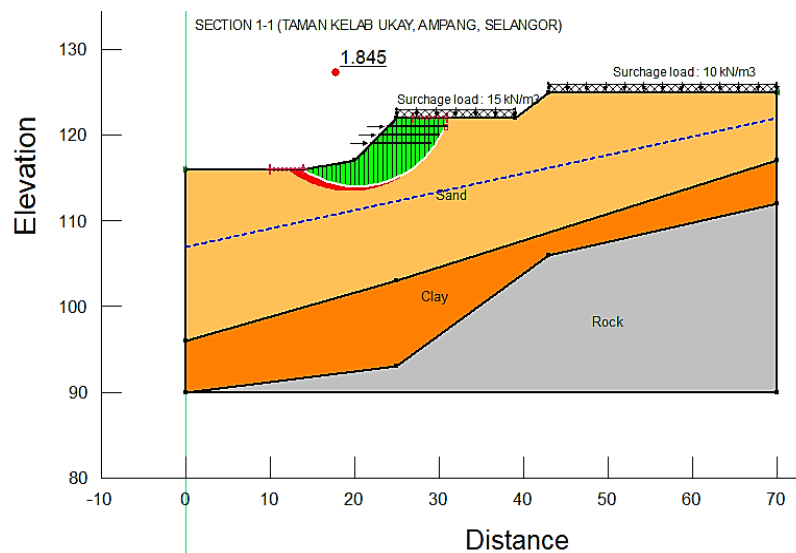
FIGURE 4. The slope analysis with 7 meters length of three (3) geotextile layers (output from SLOPE/W software)

Slope Remedial Measure by Geotextiles	
Number of Geotextile Layer	3
Length of Geotextile Layer (m)	7
Factor of Safety (FOS)	1.845

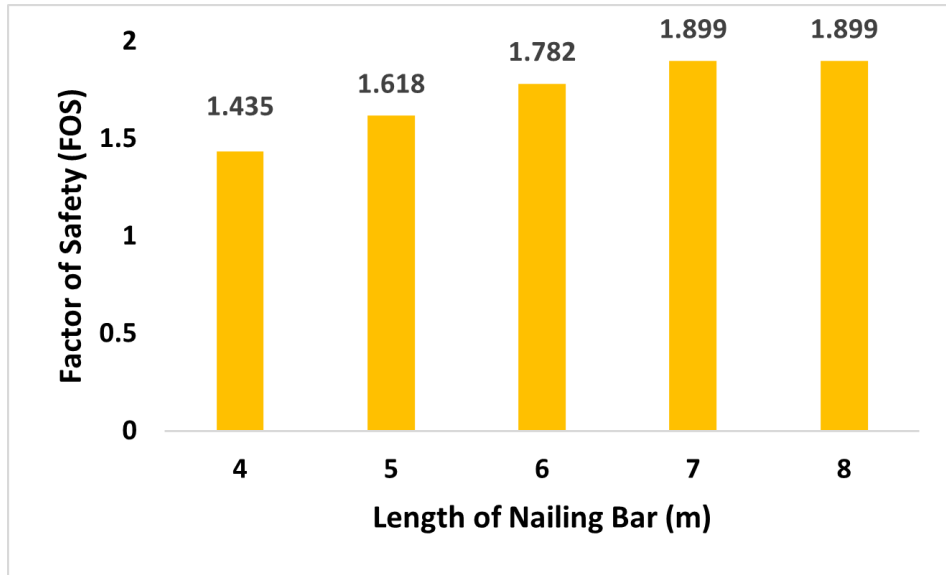
FIGURE 5. The result of FOS for various lengths of soil nailing bar

Figure 5 shows that the FOS is improved from 1.435 to 1.899. The effect trend is in line with research conducted by Alsubal et al. (2017); the slope stability improves as the length of the soil nailing increases. The most significant value of FOS for the slope is 1.899, with the length of soil nailing at 7 meters and 8 meters, respectively. In contrast, the implementation of 4 meters length of soil nailing indicates the lowest FOS of 1.435, which does not fulfil the minimum requirement of JKR Guidelines for Slope Design (2010). The 7 and 8 meters give the same result of FOS because the required bond length has mobilized the

maximum load to the slope so that the additional bond length will not mobilize any working load anymore.

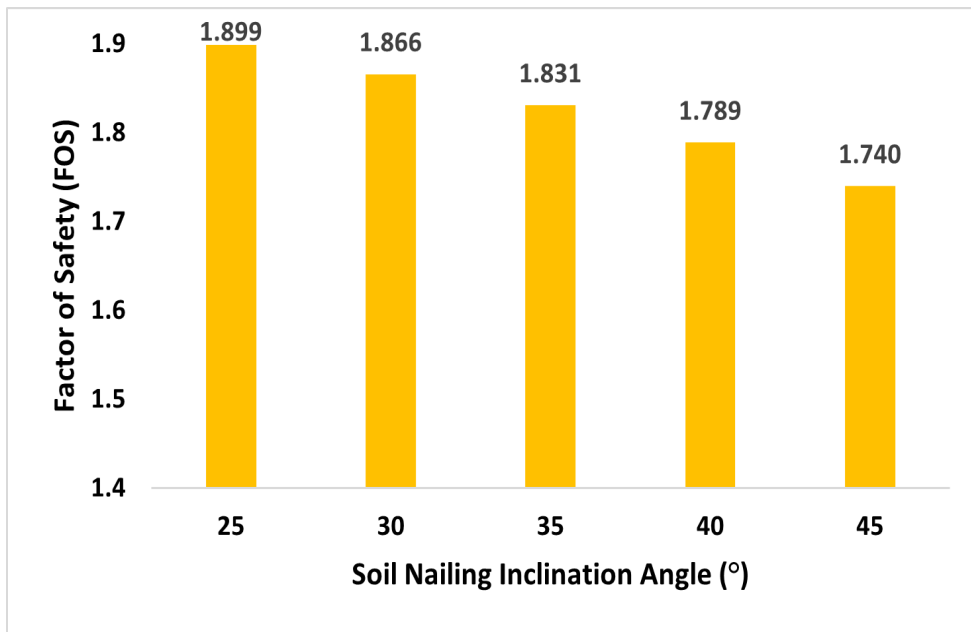
FIGURE 6. The result of FOS for various inclination angles of soil nailing bar

Then, three (3) nailing bars of 7 meters in length are designed for the following analysis to determine the ideal inclination angle of soil nailing. The proposed nail's inclination is between 25° to 45° with an increment of 5° . Figure 6 shows the graph of FOS versus soil nail's inclination angle.

Figure 6 demonstrates that the result of FOS is dropped from 1.899 to 1.740. All results from 25° to 45° fulfilled the JKR minimum requirement of 1.50 for treated slope, and this finding is consistent with the results from a previous study by Alsubal et al. (2017). They had mentioned that after achieving the optimum inclination of soil nails, the safety factor tends to decrease as the nails mobilize the maximum load in the ideal inclination when the available bond length behind the slip surface is long enough to allow the nail to use its maximum load. The results show a clear trend of decrease in FOS where 25° nail's inclination is the optimum inclination of soil nails, giving the FOS of 1.899 before it drops. The soil nailing parameters implemented in the design of this case study are listed in Table 3, and Figure 7 shows the output of the slope stability analysis from SLOPE/W software.

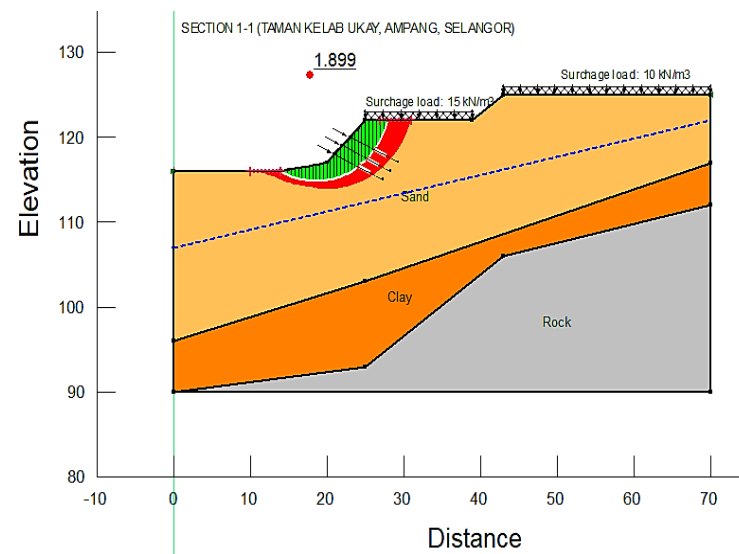
FIGURE 7. The slope analysis with 7 meters of three (3) soil nailing bars at a 25° inclination angle (output from SLOPE/W software)

Slope Remedial Measure by Soil Nailing	
Number of Soil Nailing Bar	3
Length of Soil Nailing Bar (m)	7
Inclination Angle (°)	25
Spacing between Soil Nailing Bar (m)	2
Factor of Safety (FOS)	1.899
