Influence of Iron Bacteria on the Corrosion Behavior of Carbon Steel: SEM Study

In this work, the iron bacteria were cultured and inoculated into the cooling water before immersion, and low carbon steel coupons were immersed for one month. Then, microbially influenced corrosion (MIC) of carbon steel in the presence of these bacteria was investigated using scanning electron microscopy (SEM), x-ray diffraction spectroscopy (XRD) and weight loss methods. SEM results showed that large amounts of corrosion products and heterogeneous biofilm layer were formed on the coupon surface. SEM also revealed the uniform-pitting corrosion on the steel surface due to bacteria colonization. XRD results show that the main constituents present in corrosion product are composed of iron oxides and iron hydroxides.

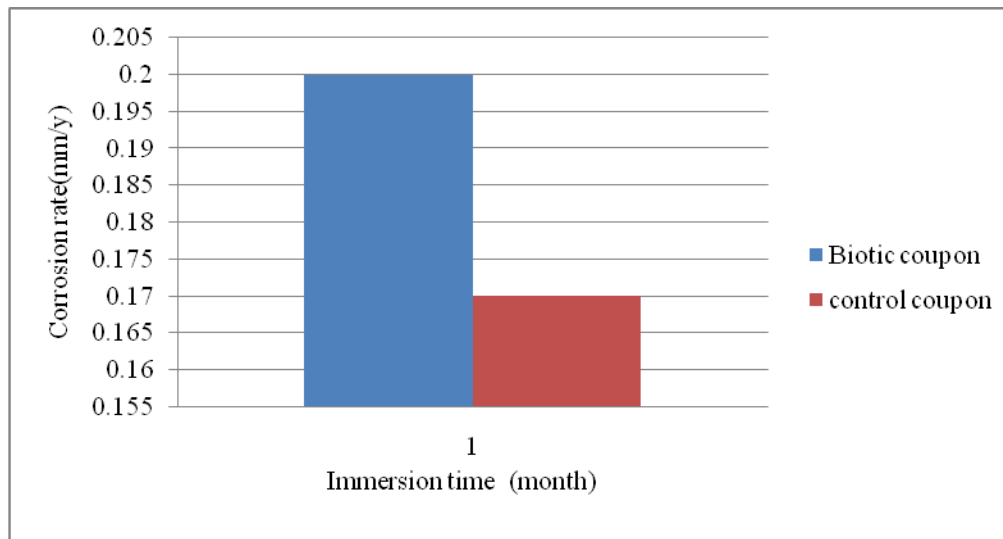
Figure 10 shows the corrosion rate of biotic and control coupons.

Figure 10 Corrosion rates of the biotic and control coupons in one month immersion time

Figure 10 shows that the corrosion rate of biotic coupons is higher than the corrosion rate of control coupons. Thus, it be concluded that iron bacteria accelerate the corrosion rate of biotic coupons. Large amounts of iron must be oxidized to
