Original Research Article

Performance of a Triangular Rubber Tracked Tractor in Paddy Fields

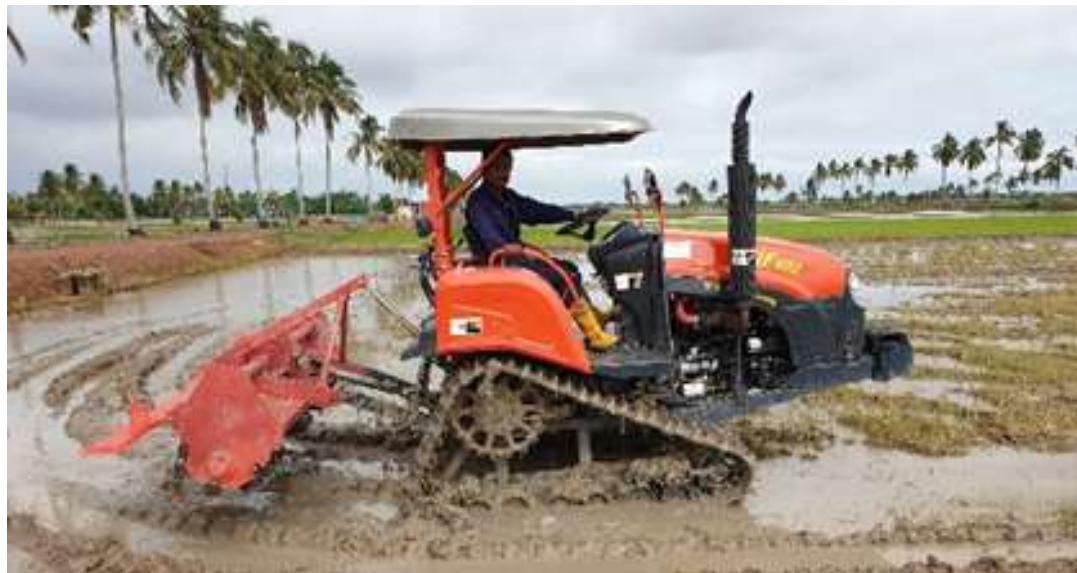
**Figure 1.** The triangular rubber tracked tractor attached with a rotary tiller.

The tractor is a fully tracked tractor with a power rating of 60 kW (80 hp) at a rated engine speed of 2400 rpm. The tractor is powered by a direct-injection, vertical, water-cooled, four-stroke turbodiesel engine. The tractor is 3.7 m long and 1.65 m wide. The tractor is equipped with a rubber track system that is driven by a drive sprocket attached at the rear end of the chassis. The rubber track is triangular shaped with 6 rollers and two idlers. Weight ballast of 120 kg was attached to the front end of the tractor. The overall weight of the tractor is 2600 kg. A rotary tiller with was attached to the tractor. The working width of the implement was 203 cm (80 in rotary tiller). The tillage depth was measured manually using a steel ruler from the soil surface to the tillage disturbance area.

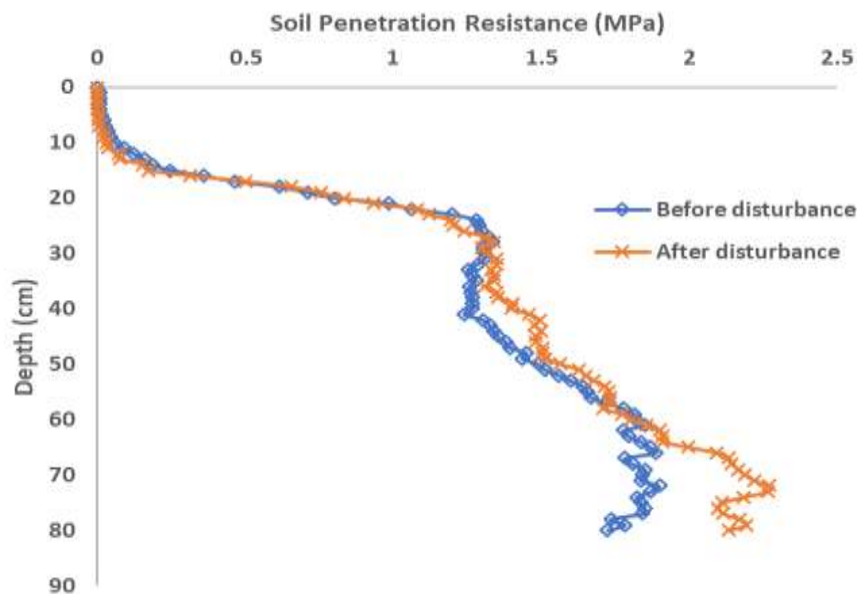
Figure 2. Soil penetration resistance of machine before and after disturbance.

Soil conditions were evaluated by the soil penetration or soil compaction. Readings of soil compaction were taken before and after the passage of the tractor, at the beginning, halfway, and at the end of the test area, with 3 replicates for each sampling area. Two types of soil compaction data were taken, which were soil compaction after passage of tractors' tracks and no disturbance which acted as the control data. The soil strength was measured up to 80 cm depth using a soil cone penetrometer (Penetrologger, Eijkelkamp, The Netherlands) with a base area of 323 mm² (ASABE, 2009). Tracks soil disturbance data was taken. No disturbance data was also taken as control. The machine sinkage was also measured. The results from the soil compaction were analyzed using ANOVA (SAS, 2015).

The soil effects after tractor disturbance was not significant ($t = 0.30$, $p = 0.763$). This showed that the low ground contact pressure of the tracked tractor has minimal effect on typical paddy fields. Although the working depth of the machine is 40 cm, the graph shows that there is no significant damage to the soil strength at 0–40 cm. This tractor will be useful

for fields that are currently without any soft soil condition, as results here show no significant effects.
